Greensolver BESS Case Studies

CASE STUDY 1

Due Diligence for Belgium's biggest BESS project : 50MW / 100MWh (BL)

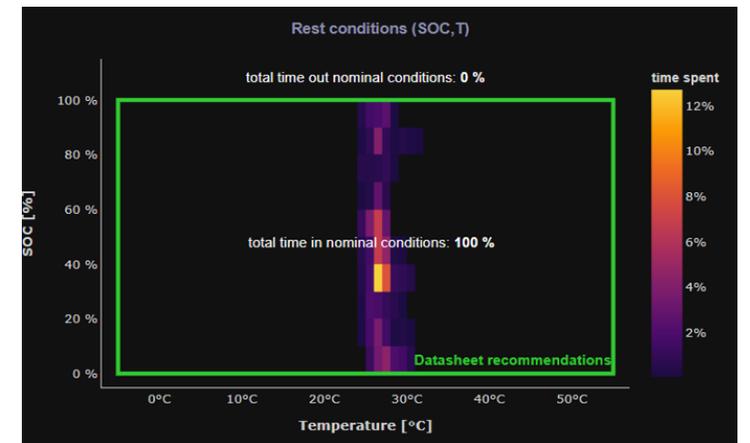
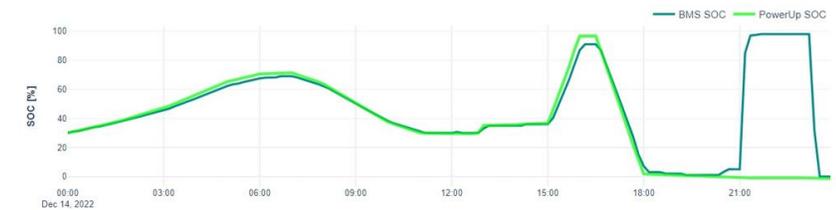
Thanks to the **temperature, voltage and current** data given by the SCADA at battery rack level, Greensolver was able to analyse :

- ✓ **State-of-Safety:** by tracking **over-voltage / over-temperature / cell imbalance** to prevent Thermal Runaway
- ✓ **Performance:** by checking estimation and accuracy of **SOC** and **SOH / BMS faults**
- ✓ **Lifetime:** by checking **operational condition vs battery OEM requirements** (temperature, C-Rate)

This **Safety & Performance analysis** allowed us to highlight issues, which were subsequently raised to the battery OEM :

- ✓ **State-of-Safety:** **frequent cell imbalance** caused by weak cells, which could then lead to over-voltage and over-charge in the Battery cells and at the end **Thermal Runaway**
- ✓ **Performance:** **remaining useful capacity (SOH) below the warranty** of the battery OEM / frequent faulty measurement of the BMS, leading to **SOC deviation** (wrong voltage measurement)
- ✓ **Lifetime:** **higher temperature** of the battery module than recommended, which could accelerate ageing

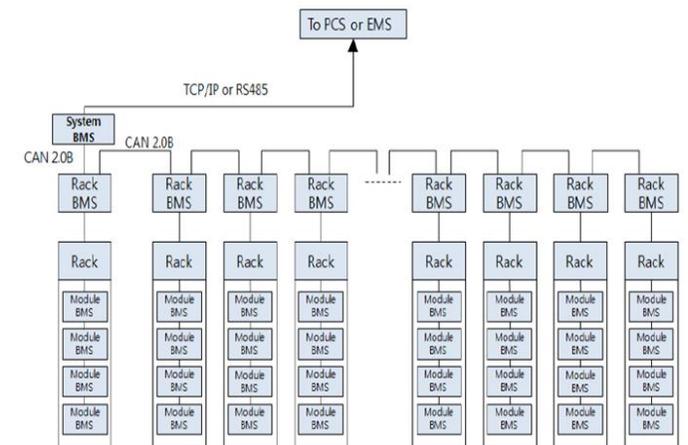
[Fig 16] Communication block diagram

- ✓ BMS and EMS
- ✓ EMS and Bachmann controller
- ✓ Bachmann controller and VPP controller of the RTM operator

We saw that all the protocols met the requirements, they were all IEC104.

Then we analyze the main equipment involved: BMS (Samsung), including ModuleBMS, the RackBMS and the BankBMS/SystemBMS.

We found that the EMS allowed 7 modes and we gone through the way in which the different modes change depending on the commands received (again checking the communication equipment and protocols). They **did not correctly send the orders to the batteries**, so they do **not comply with the timeframe**.

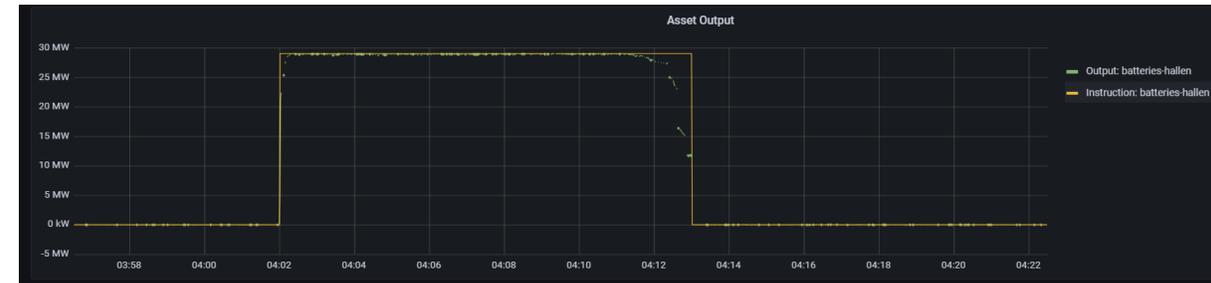
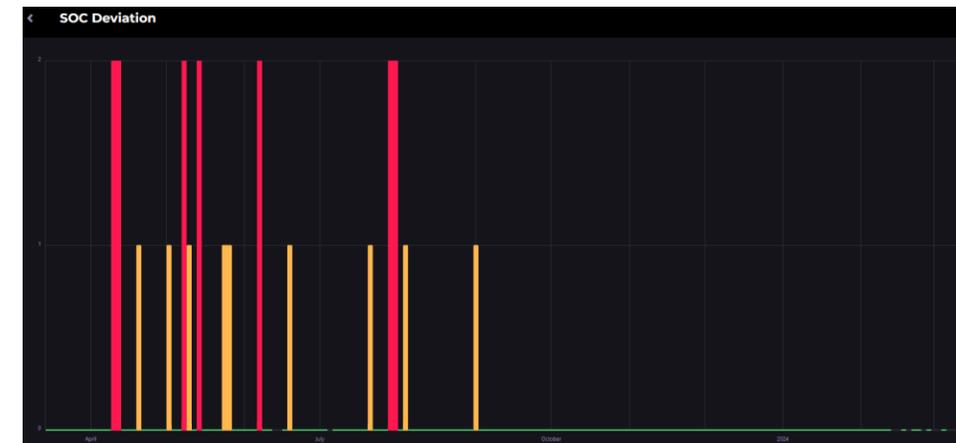
- ✓ **First**: by tracking those alarms, **Greensolver team** could focus **cause on the BMS**
- ✓ **Second**: **Greensolver team** requested **remedial action to the Battery OEM**
- ✓ **Third**: **Battery OEM performed a software update** of the BMS to improve the SOC calculation

From the **date of the software update**, **no more critical SOC deviation** alarm have been raised. The **RTM operator gained visibility** of the position the asset in the market, reducing the risk of discrepancy.
